## SERVICE INSTRUCTION no. 2012/2 – revision no. 1 Replacement of pressure reducer piston at Ignis burners

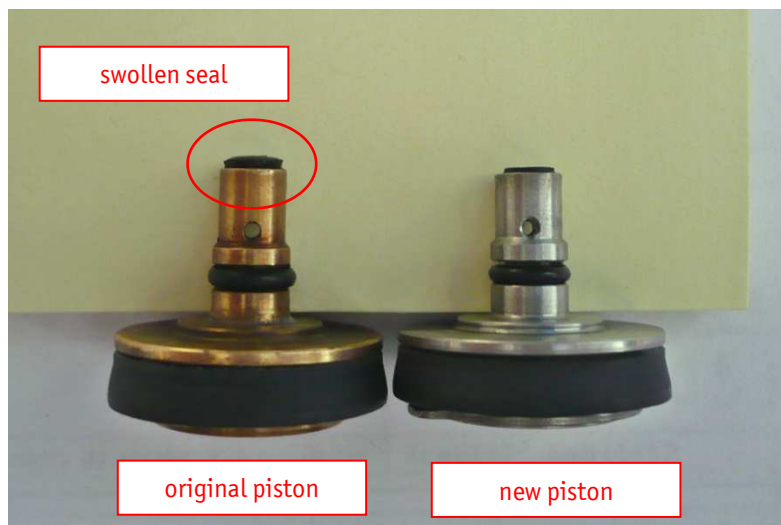
At Ignis burner units a swollen seal of the pressure reducer piston can cause pilot flame malfunction - the flame burns irregularly or goes out completely.

Comparison of pistons:

1. Remove the pilot burner out of the burner unit, disassemble and clean it.
2. Replace the piston with the new one (part no. 53123.00\_ND).
3. Assemble the pilot burner and install back to the burner unit.
