SERVICE INSTRUCTION no. 2024/03 Loose passenger handle line

With reference to: Kubicek Ballons K-series baskets

Action: Regaining friction of upper handle line after repair of wickerwork

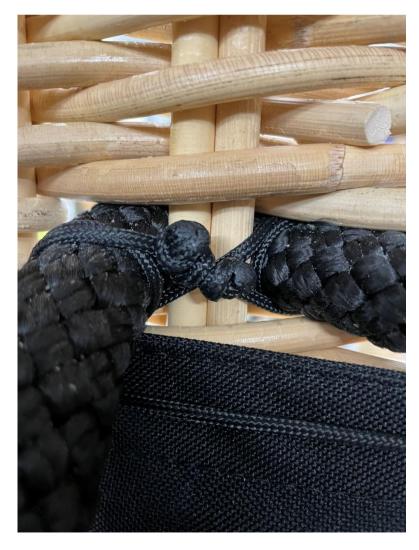
- 1. Identify loose handles. Locate the handles that are loose and need securing.
- 2. Using a 3 mm nylon line, wrap it around the thick rope where the handle begins. Secure the wrapping by tying knots at both ends of the nylon line (refer to the image below for proper technique).

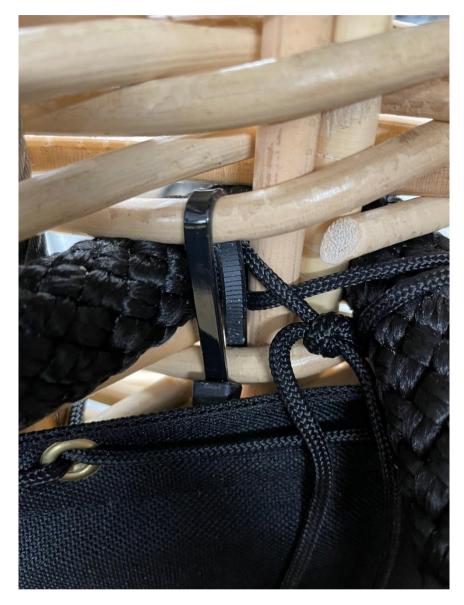
3. To ensure sufficient friction between the thick rope and the wickerwork, place cable ties around the wicker near the base of the handle. Make sure to position the cable ties so that the locking mechanism is hidden within the woven structure, protecting passengers from any sharp edges (refer to the image below for placement).

- 4. Cut off the excess ends of the cable ties for a neat finish.
- 5. Apply the same process to all handles that need securing.
